SPECIAL AIRWORTHINESS INFORMATION BULLETIN

SW-05-82
August 19, 2005

This Special Airworthiness Information Bulletin alerts you, owners and operators of **Agusta S.p.A. Model A119 helicopters** with an air conditioning compressor installed by **Air Comm Corporation** Supplemental Type Certificate (STC) Number SR00463DE of an issue with the compressor drive belt.

Service Bulletin: SB A119-3024; Agusta A119 Air Conditioner Oil Cooler Inlet Screen Assembly, Compressor Safety Strap Installation, Engine Governor Control Cable Guard and Replacement of Compressor Drive Belt.

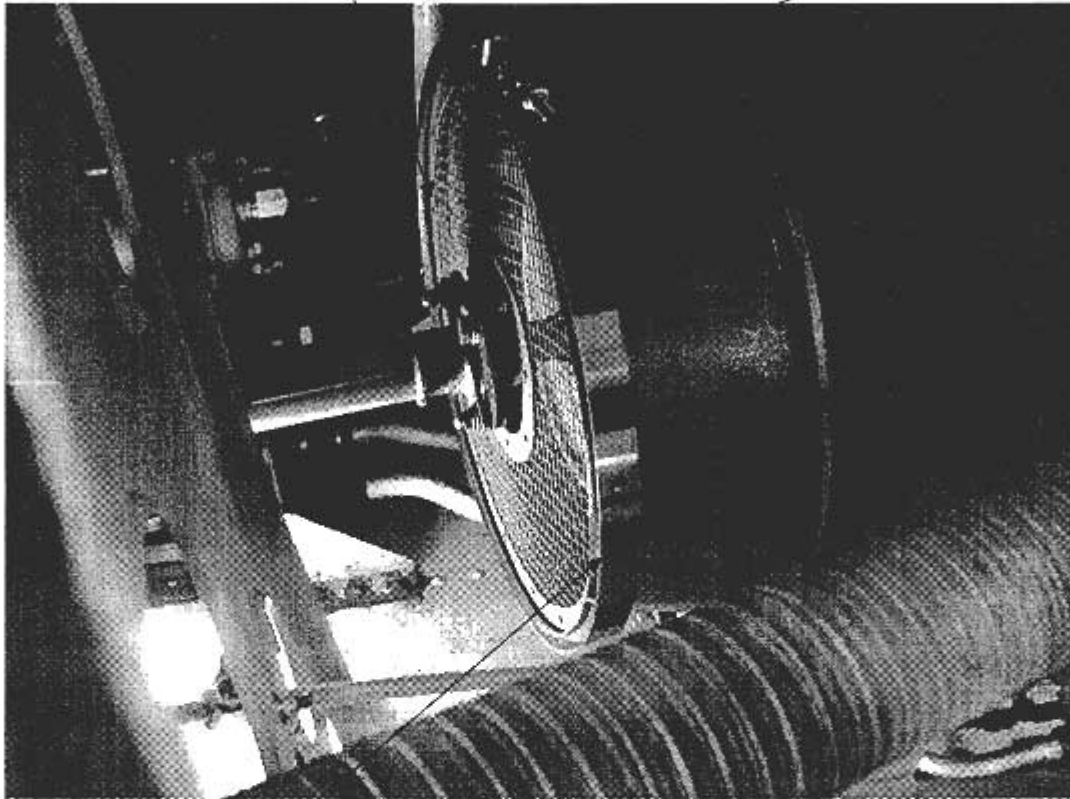
Figure 2

1. The addition of this screen is the result of a recent belt breakage incident which caused substantial damage to the oil cooler blower fan blades. ACC is providing an inlet screen and clamp assembly to be installed on the inlet side of the oil cooler blower housing. The new inlet screen assembly will provide the necessary protection to prevent future mishaps of this nature from occurring.

1. Install A119-3024-1 screen assembly between the driveshaft segments placing the screen securely on the forward flange of the oil cooler blower housing.
2. Install the 994FM-1075 clamp around the screen and blower housing flange, and secure in place. Torque the clamp retaining nut to 50 in-lbs, and safety the retaining bolt and clamp halves using .032 safety wire.

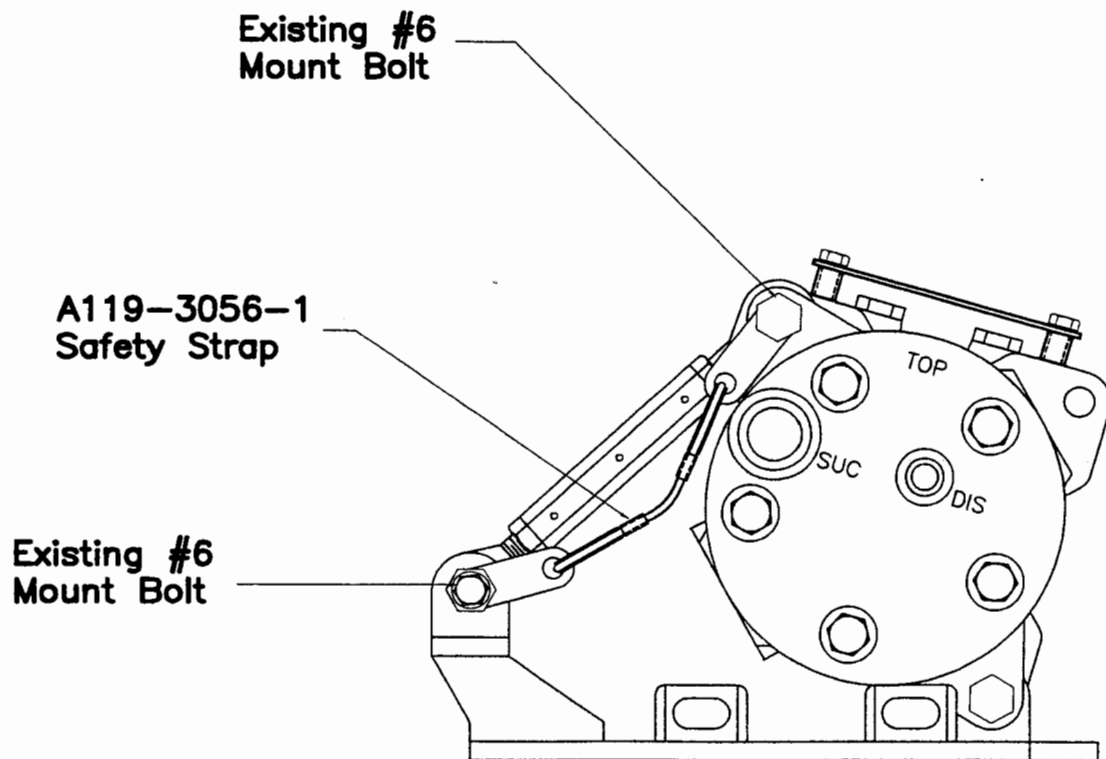
Figure 3

2. The addition of a safety strap on the compressor mount is to restrain the compressor in case of failure of the belt tension link.
3. The addition of a governor control cable guard to protect the cable in case of debris from a broken air conditioner drive belt.
4. Replacement of the compressor drive belt to assure that every ACC A/C equipped A119 has a new belt that is properly aligned and tensioned.

1. Remove Nut from bolt on upper end of belt tension link as shown in Fig 3.
2. Remove bolt from lower end of belt tension link.

3. Install tab under nut and washer on upper end of belt tension link.
4. Install lower tab end under bolt as shown in figure 3.

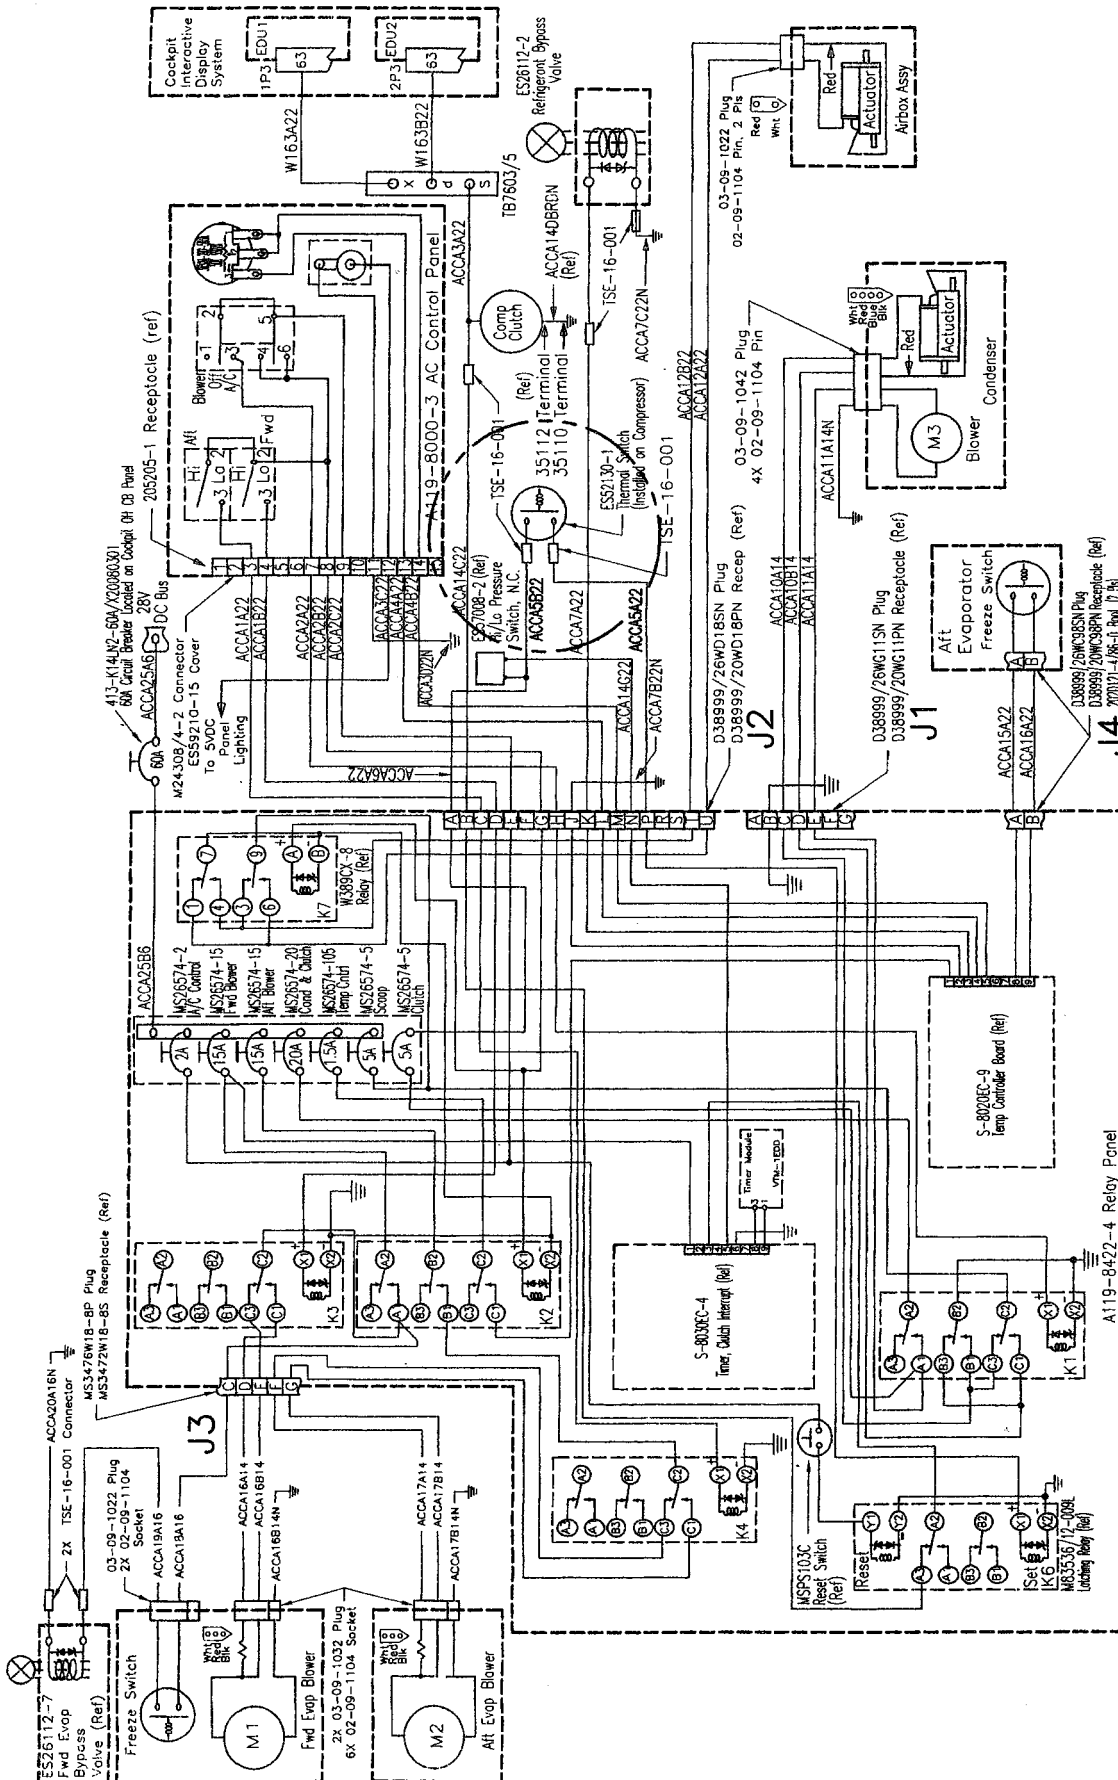
Figure 1.1

The new A119-3040-1 Compressor assembly is not equipped with a temperature sensor, therefore the need to cap and secure wires ACCA5A22 & ACCA5B22 is required to comply with this Service Bulletin.

2. Disconnect #8 and #10 refrigerant lines from the ports located on the aft side of the air conditioner compressor body. Remove and discard O-rings from hose fittings. Cap lines to prevent contamination, and oil loss.
3. Cut safety wire, and loosen Jam nuts on compressor belt tensioning link assembly. Turn the barrel section of the link assembly to loosen the compressor belt tension.
4. Disconnect the Compressor clutch wire at the compressor.
5. Disconnect and Cap wires ACCA5A22 & ACCA5B22 connecting to the compressor temperature sensor wires using two each 35115 caps, and secure wires as necessary. (Figure 1.1)
